Reference XNS-T05 Stabilator Substructure
Scale: 1/2

This Sketch provides the information necessary to use the XNS-T06-07 Tip Ribs which were manufactured with 3/16" diameter holes in lieu of 3/32" diameter holes

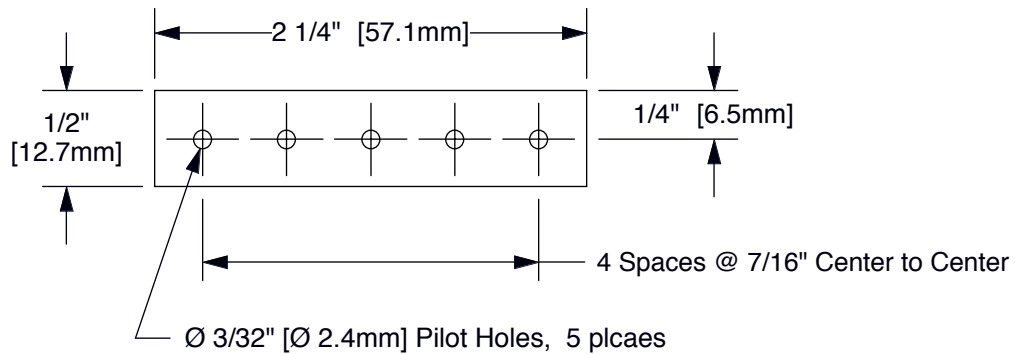
Repair Plate - .032" Thick 6061-T6 Aluminum
